Volume V

Appendix G.8

**USING THE DATA AND OBSERVATIONS FROM FLIGHT STS-107 TO EXPLAIN THE
FATAL REENTRY OF THE COLUMBIA ORBITER OV-102**

By
DR. JOHN J. BERTIN
DR. JAMES W. SMILEY
CONSULTANTS, CAIB SUPPORT GROUP

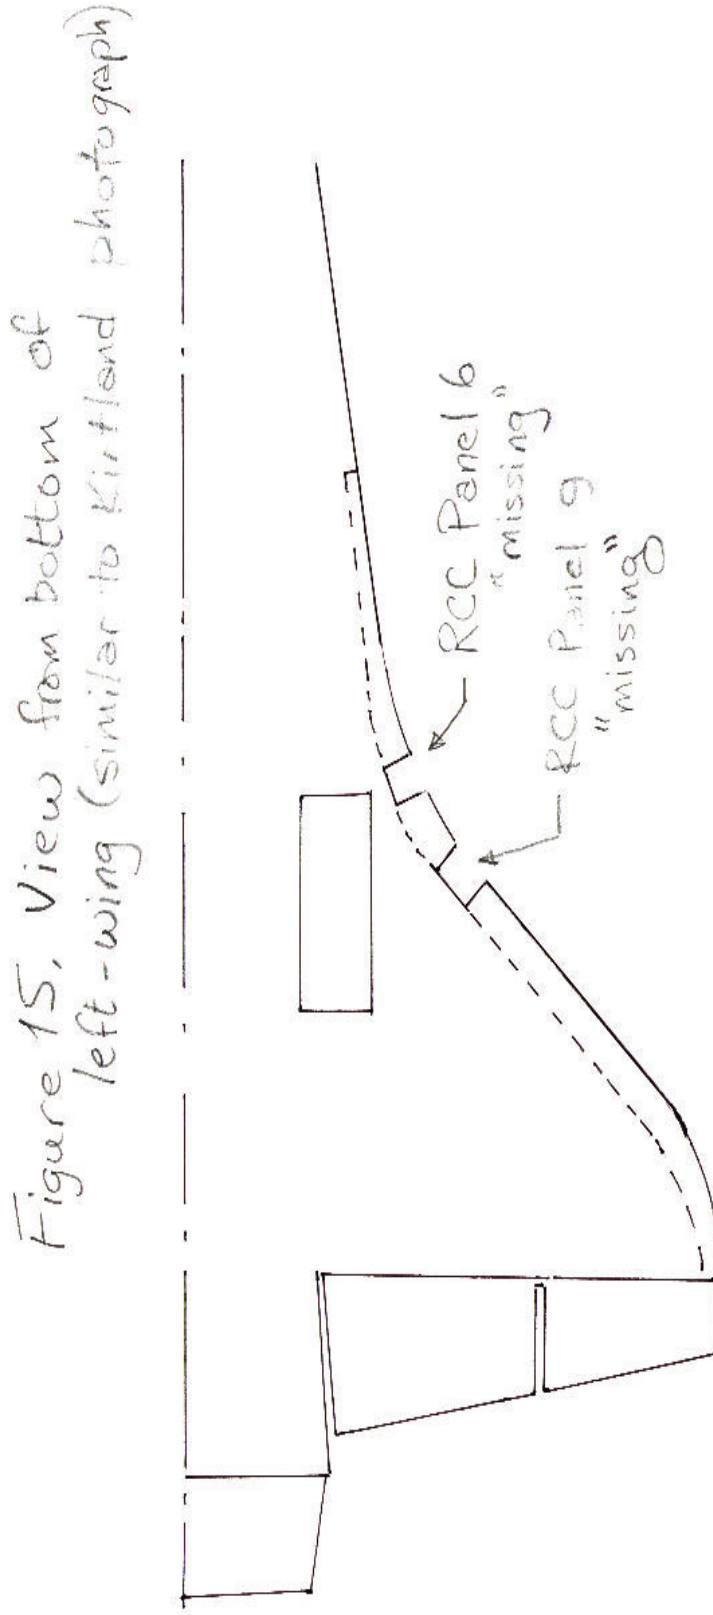
Figure 22

oncoming flow sees cavities or notches in the wing leading edge, flat faces of (what is left of) the spars, metal surfaces of high catalycity, etc. See Figure 22. Locally strong shock waves that are imbedded in the viscous/inviscid interaction change the nature of the interaction to one more like that of Figure 8(b). A significant increase occurs to the perturbations in heating to the erose leading edge formed by the damage to/loss of those RCC panels in the “transition zone”, e. g., RCC Panels 6 through 9. All of this, occurs with the Orbiter flying at velocities in excess of 22,000 feet/second (Mach 22.5) and at an altitude of 227,000 feet where the flow is a continuum and the aerothermodynamic environment is severe.

As noted in the previous paragraphs, debris events 1 through 5 take place from GMT 13:53:44 to GMT 54:11. See Tables 1 and 3. A number of tiles and/or pieces of individual RCC panels along the leading edge have been ablated, or lost. See Figures 20(a) through 20(c) and the “The Content of Left RCC Panels” in Table 2. Consistent with our premise, let us assume that there are at two gaps due to “missing” RCC panels from the wing leading edge. Missing is in quotes because parts of the panels are probably still in place. Furthermore, each notch may represent one or more RCC panels. Recall from the previous discussion that the initial, critical, foam-impingement-induced damage possibly affected RCC Panel 6 \pm one panel. The early and rapid responses of the three sensors near the spar behind RCC Panel 9 led to the postulation that hot gases were flowing through the chunnel. The significant amount of metallic deposits on left-wing materials presented in Figure 21 further supports the contention that damage to RCC Panel 6 was the initial breach. Downstream, leading edge RCC panels were being heated from both sides, with disastrous effects. The most disastrous were to the RCC panels located where the shock/shock interaction heating was the greatest, RCC Panel 9. Thus, based on the previous discussion, we will assume that the two notches are centered on RCC Panel 6 and on RCC Panel 9. Refer to Figure 22.

View From Bottom of Left-Wing (Similar to Kirtland Photography)

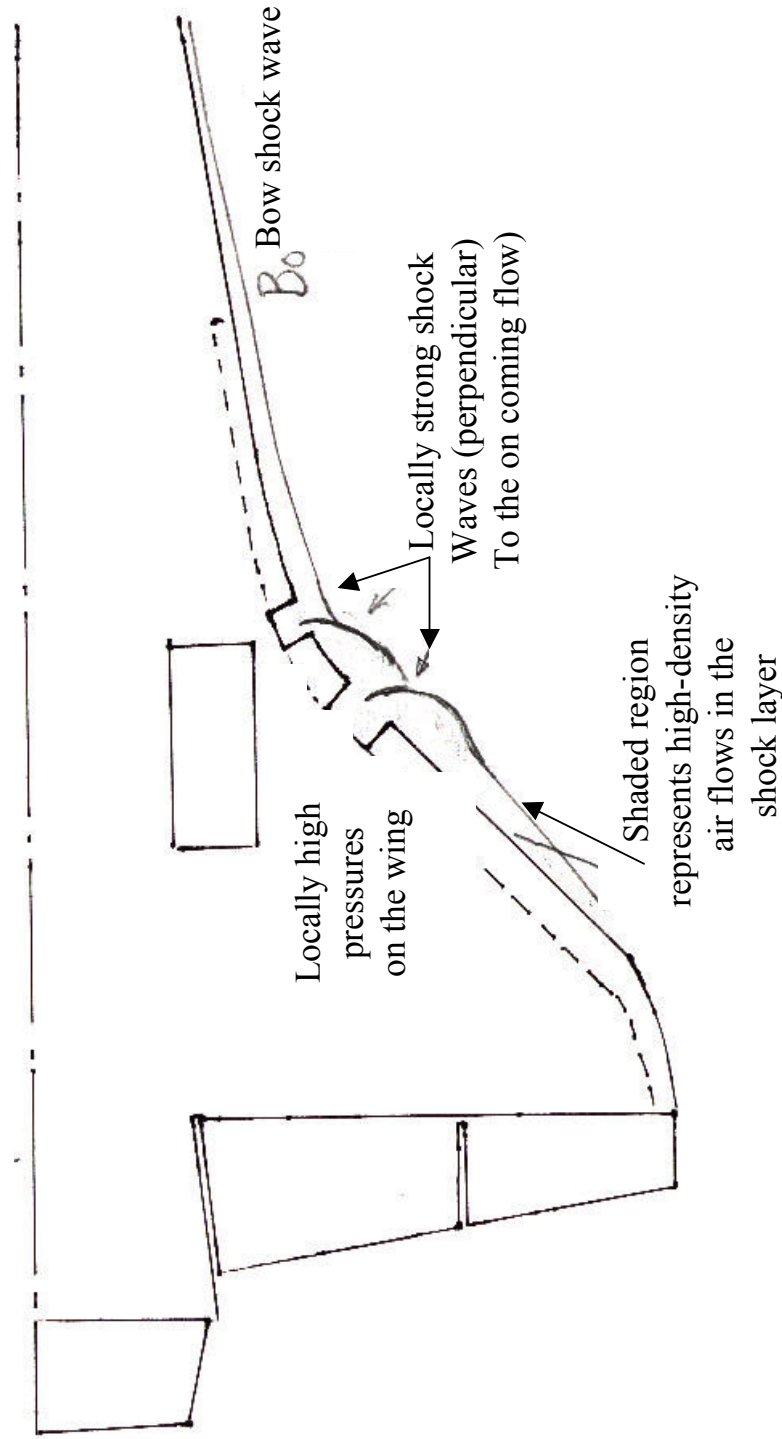
The shock-layer structure postulated for each notch in the sketch of Figure 23 is similar to that obtained during the Mach 6 wind-tunnel tests that were conducted at the Langley Research Center. See Figure 24. Consider the curved shock wave associated with the notch created by the removal of RCC Panel 9 from the wind-tunnel model. The trace of the shock wave nearest the wing root, i. e., the trace that extends into the notch produced by the missing RCC Panel 9 is normal to the oncoming flow. Thus, the flow

Shock-Shock Interaction for Left Wing, as Modified by Missing RCC Panels (RCC Panel 6 and RCC Panel 9)

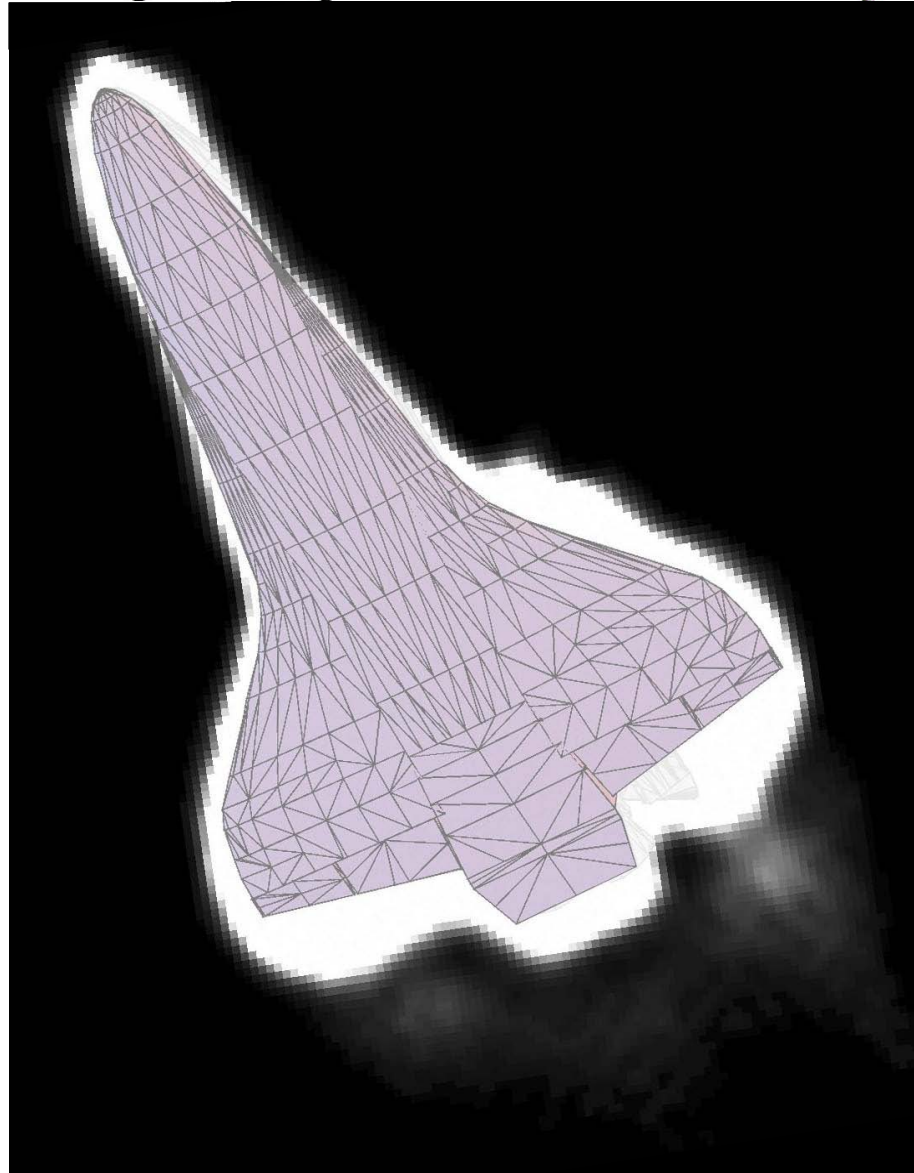
Image straight overhead from Albuquerque
Approximately 13:57:24 GMT

Gregg Byrne's team
thinks this apparent
feature is real

Are RCC panels hinged
up?

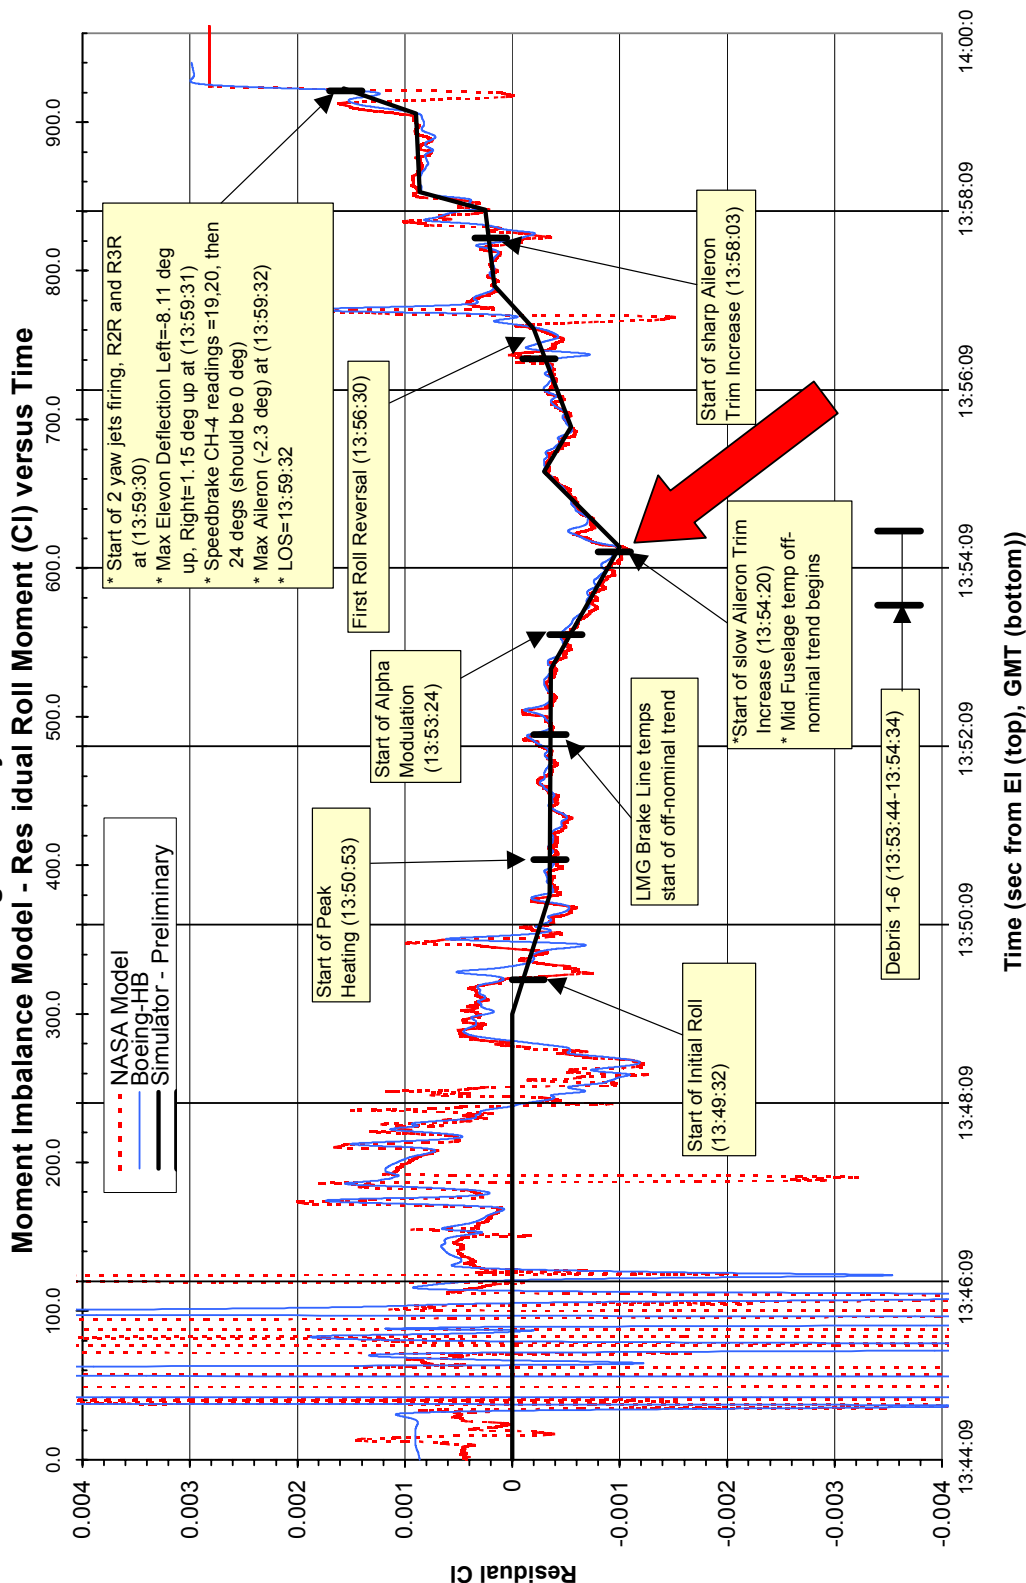
Figure 30

The delta rolling moment history is presented in Figure 30. The strong oscillatory variations of the delta rolling moments that occur before GMT 13:50:00 were attributed to experimental uncertainty from the outset, as noted by Labbe et al. [Ref. 3]. From GMT 13:50:00 through GMT 13:53:00, the delta rolling moment was relatively constant and negative. The magnitude is within the experimental uncertainty. Furthermore, additional review of these data indicated that there had been flight-to-flight variations of similar magnitude from previous flights. Winds were offered as another factor that could have affected the data in this time frame. Because of these three factors, the authors have assumed that none of the delta rolling moment data for times before GMT 13:53:00 are definitive.

From GMT 13:53:00 to GMT 13:54:00, the delta rolling moments are negative (left-wing down) and becoming more negative with time. See Figure 30. In the same time frame are the first five debris events. Recall that, for the flow field that was computed for the Orbiter with RCC Panel 6 missing, there were negative rolling moments of small magnitude. See Figure 12.

Sharp Change in Rolling Moment

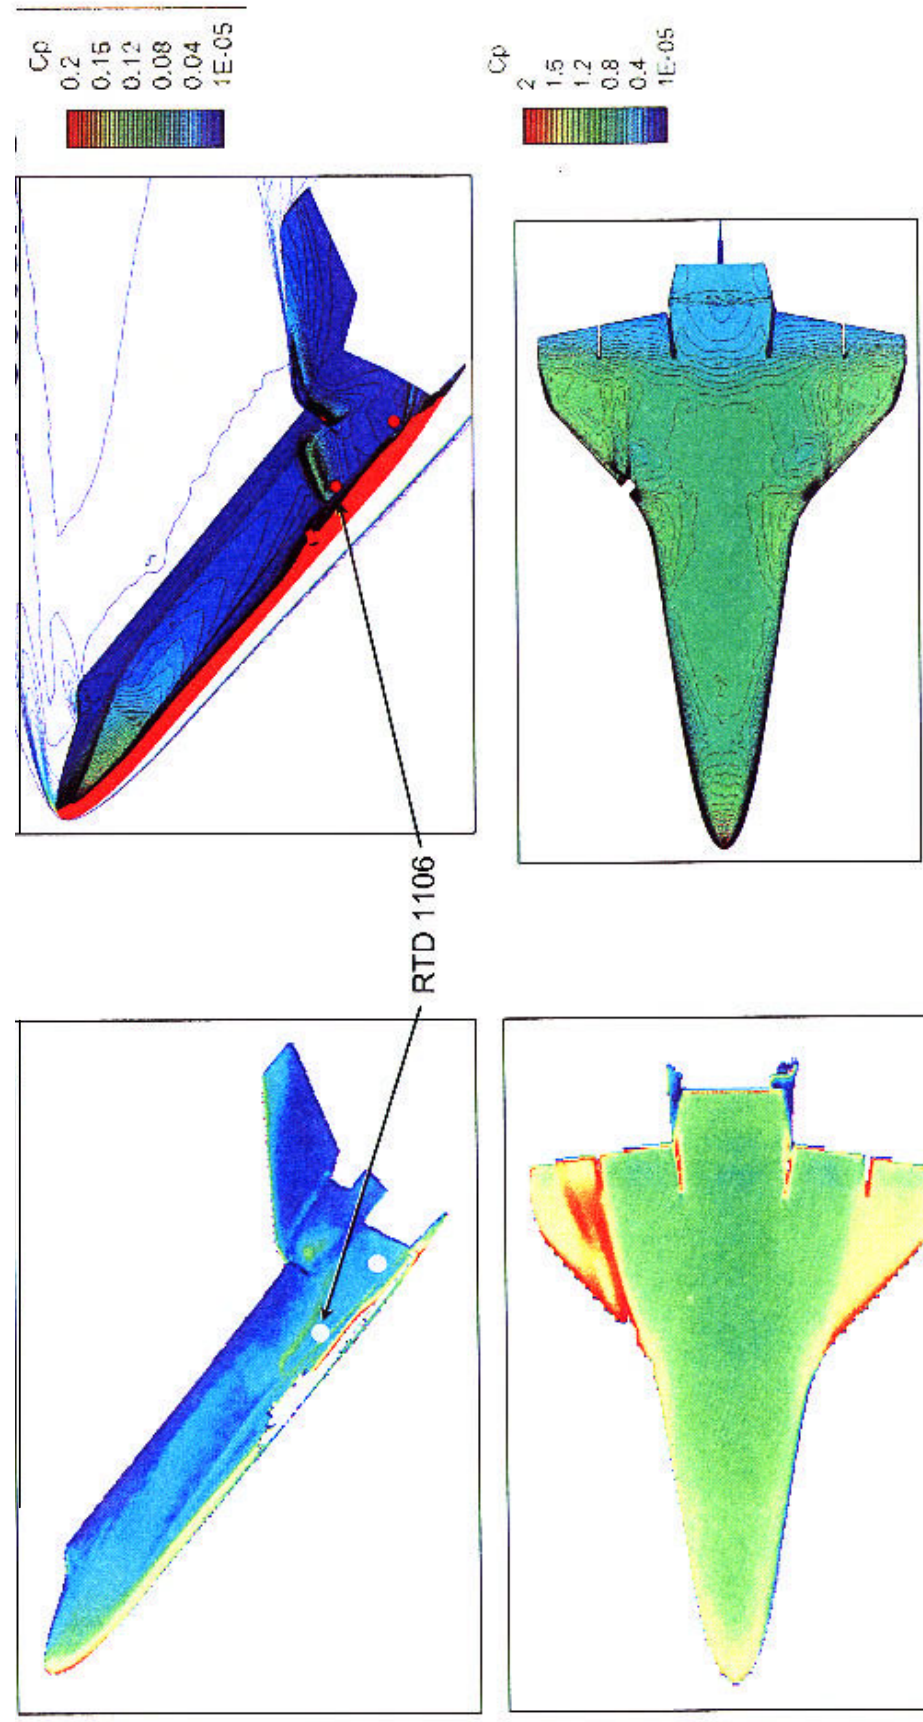
Figure 31

High pressures act at the notch left by the loss of RCC Panel 9. The probable loss of a good portion of the spar behind that RCC panel provides a path for the hot gases to create devastation to the structures in large areas of the internal wing volume. Although temperature measurements in the LMG wheel well have been indicating problems for over two minutes, the damage to the wing front spar and internal struts is increasing. The timeline presented in Table 1 indicates that, during the same time frame that first five debris events occur. It is likely the upper interior wing honeycomb surface is being heated above the RTV (tile bonding adhesive) failure limit and the tiles are coming off. It is also possible a larger section of the honeycomb aluminum burns or comes lose which could correspond to the flash (burning of the vaporized aluminum) observed in this time period.

Missing RCC Panel 9 – Surface Flow Features
